## Confidential Inspection Report

LOCATED AT:  
Any Street  
Stafford, Virginia 22554

INSPECTED ON:  
Tuesday, April 7, 2015

Inspector: David Grant  
ASHI Certified Inspector  
Virginia Certified Home Inspector  
Eagle Eye Home Inspections  
(703) 670-4663

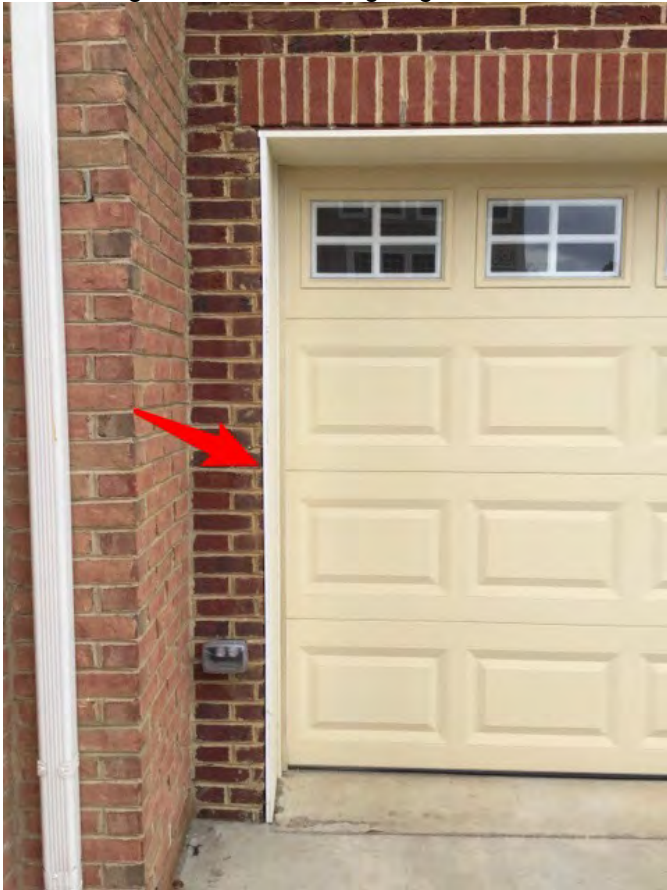
**1: -** Missing trim at left side of garage door. Recommend installation

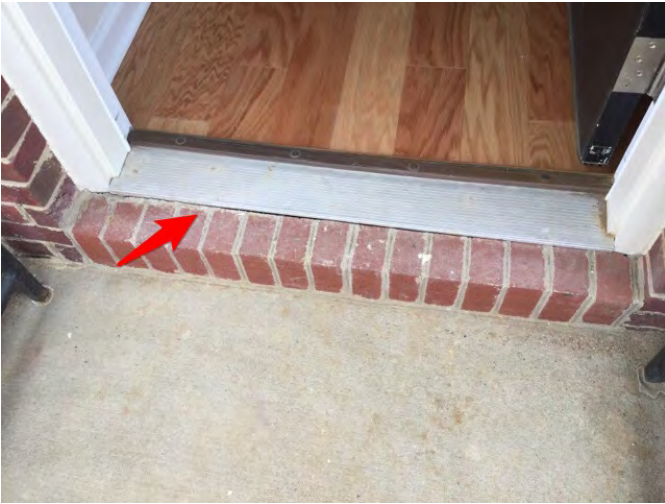
2: - Gaps between brick and threshold at front door

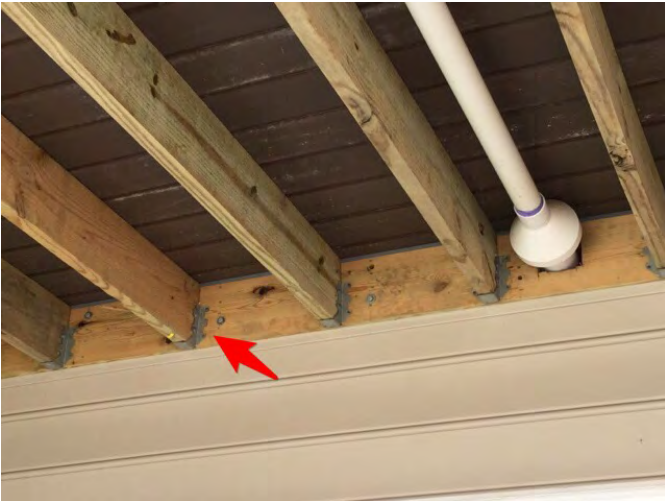
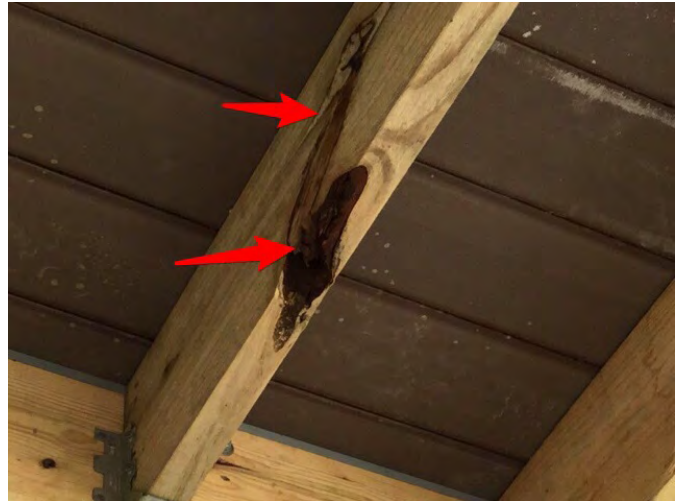
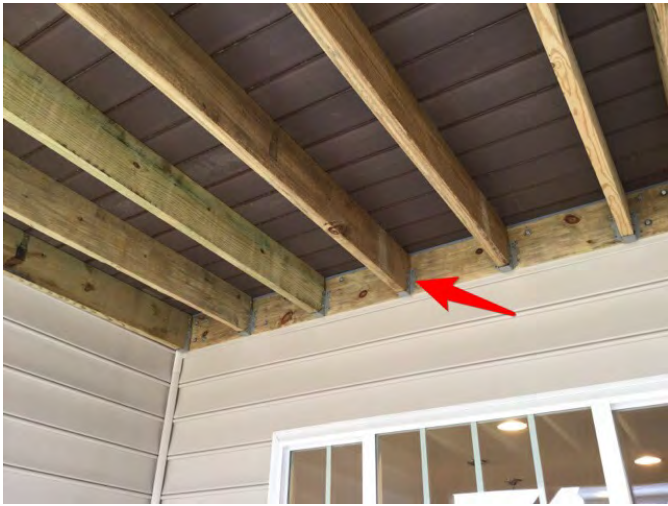
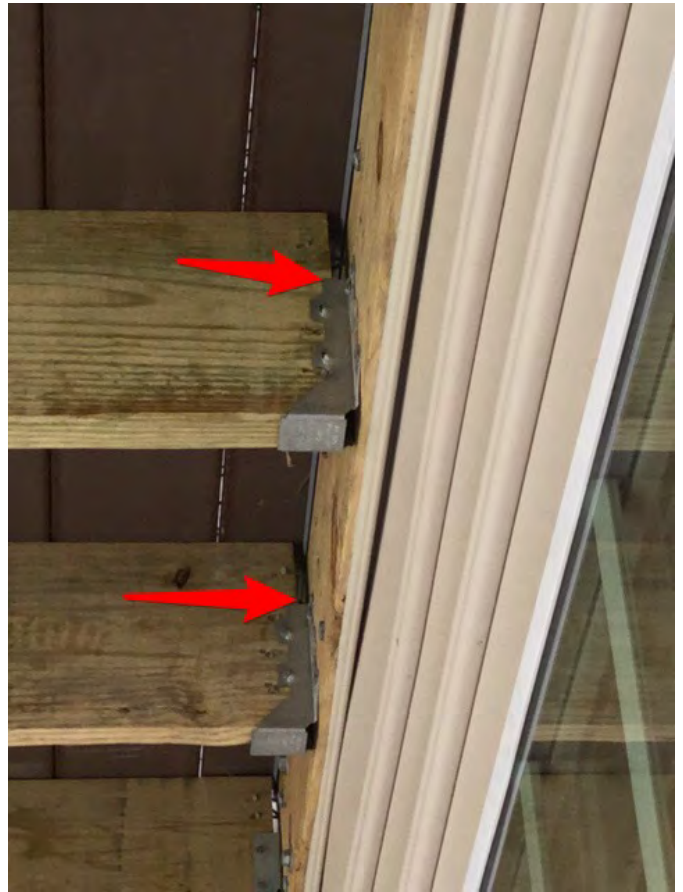
3: - Joist hangers do not appear to be correct size for the joists at both levels. 2nd joist from this units exterior wall has significant knot that weakens board. Too much space between ledger board and joists at several joists. Recommend review by a qualified licensed contractor for repair/replacement as necessary for safety

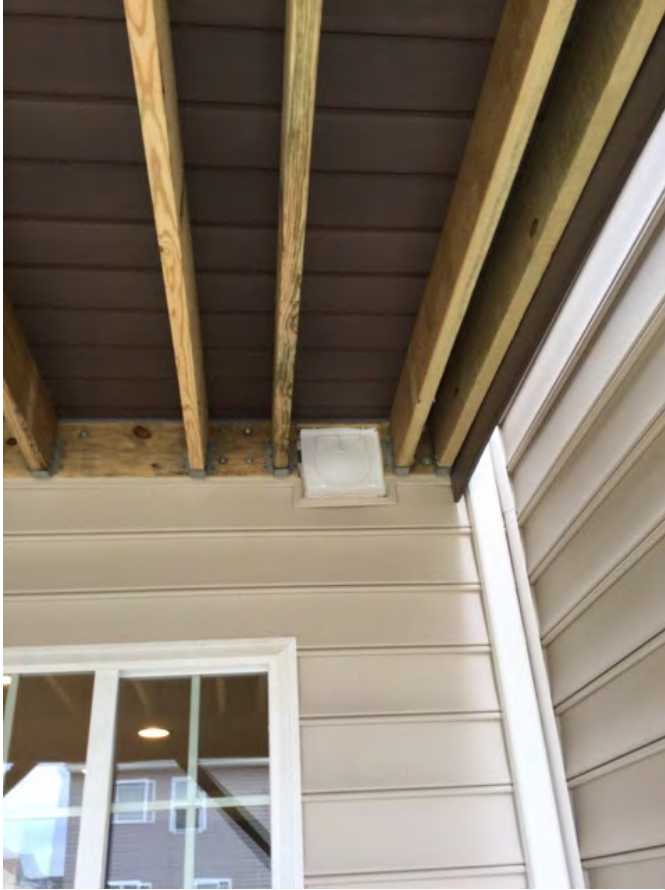
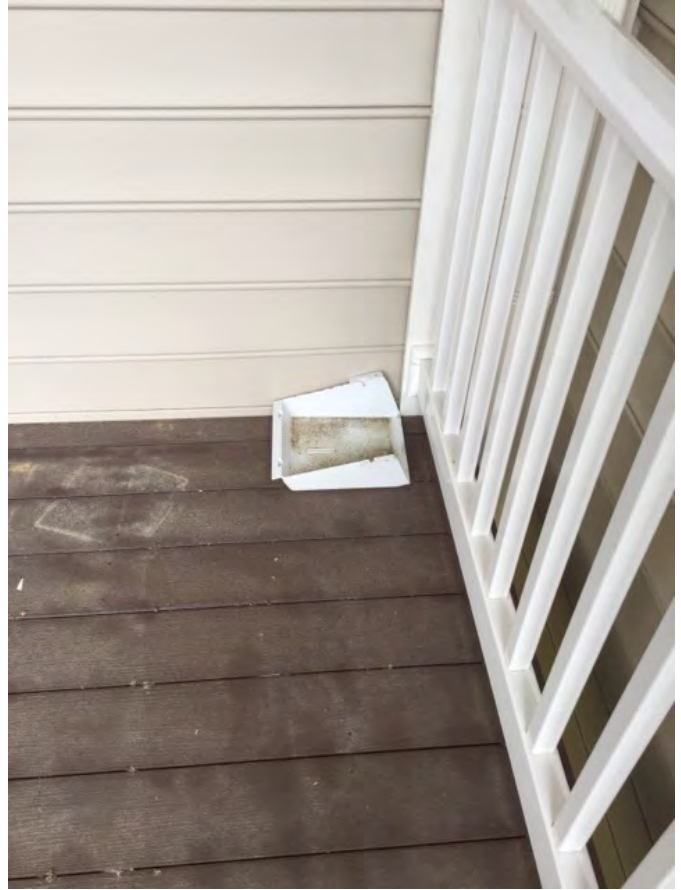
4: - Exhaust vent cover is not installed. Repair needed

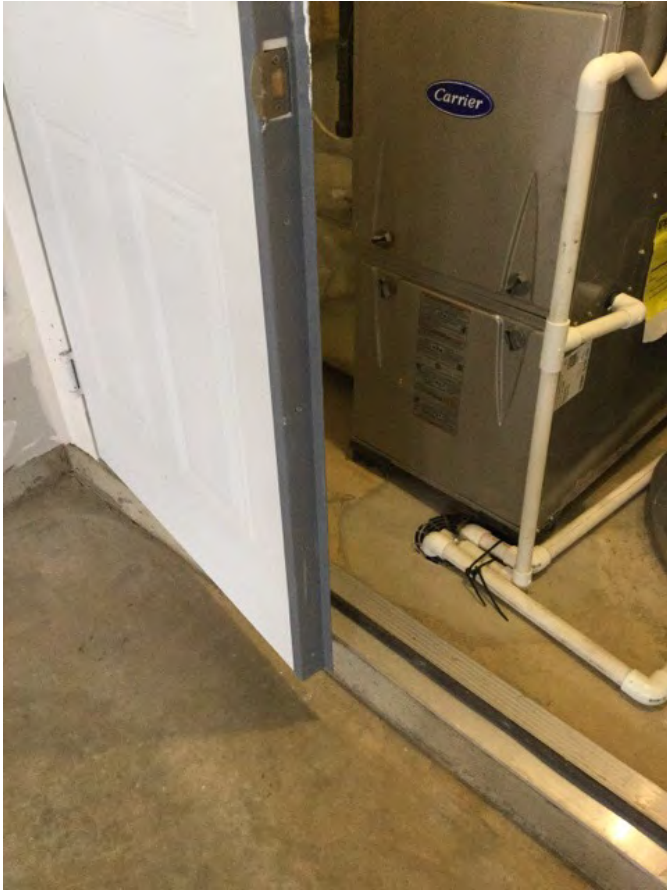
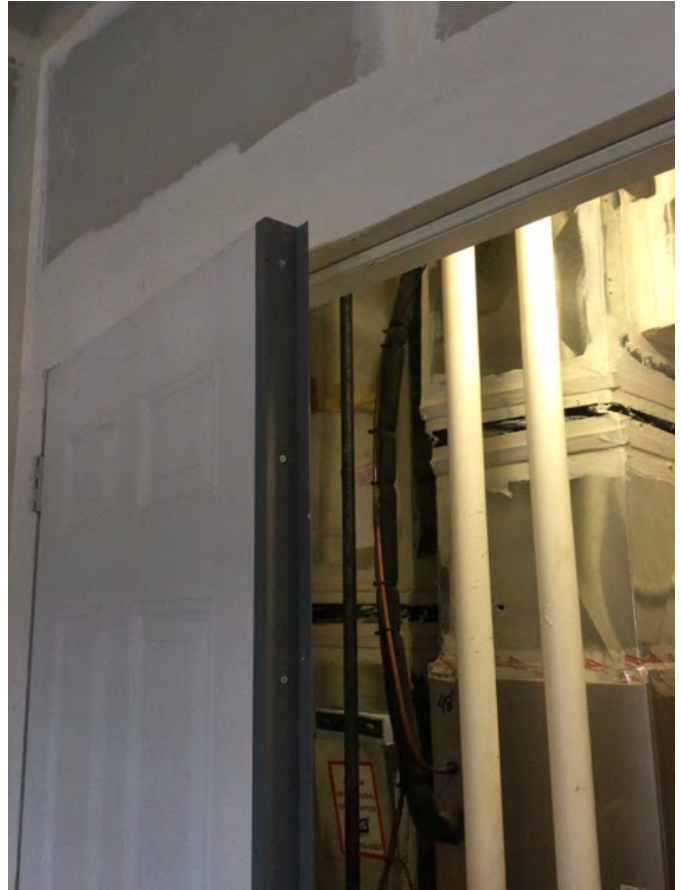
**5:** - Fire door at furnace room does not have latches to secure at top and bottom of frame for striker plate side door. No seal at edge between doors. Air pressure would cause door to open during a fire, allowing fire into interior. Recommend repairs for door to latch and properly seal for fire safety

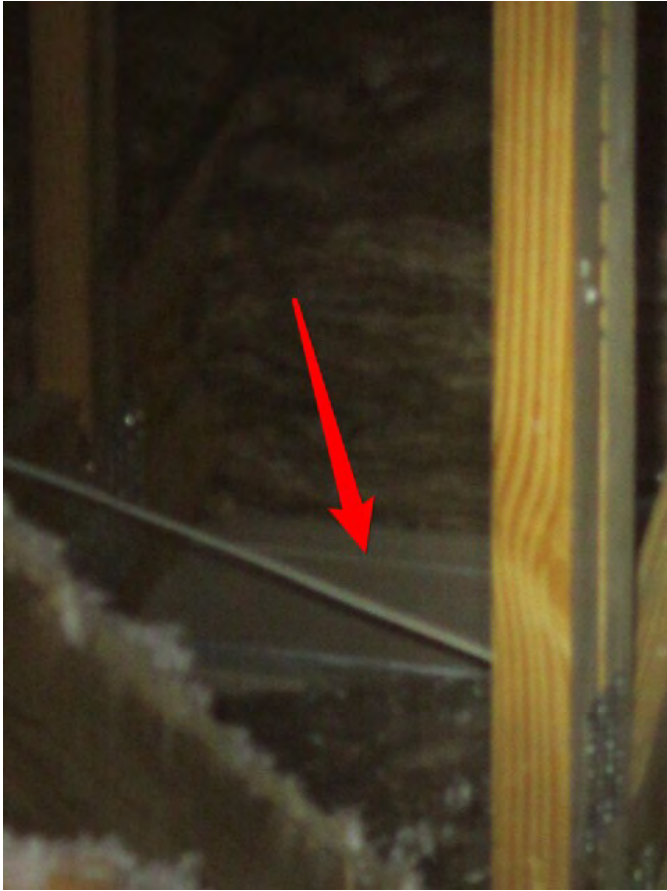
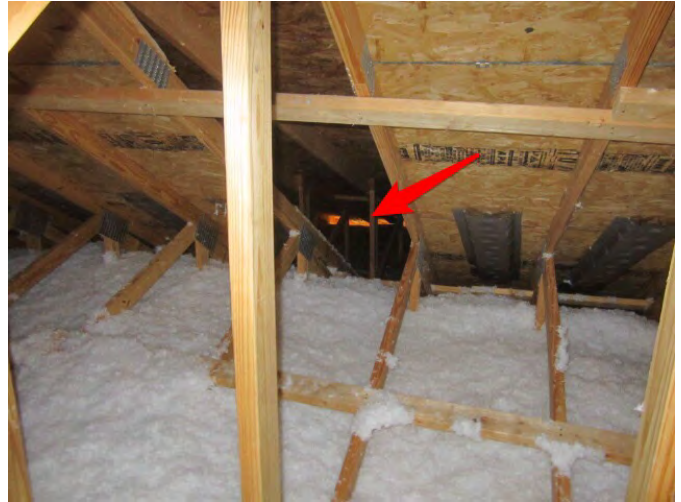
**6:** - 10-14" of insulation present except for missing piece/bare area above master bedroom. Recommend installing insulation where missing

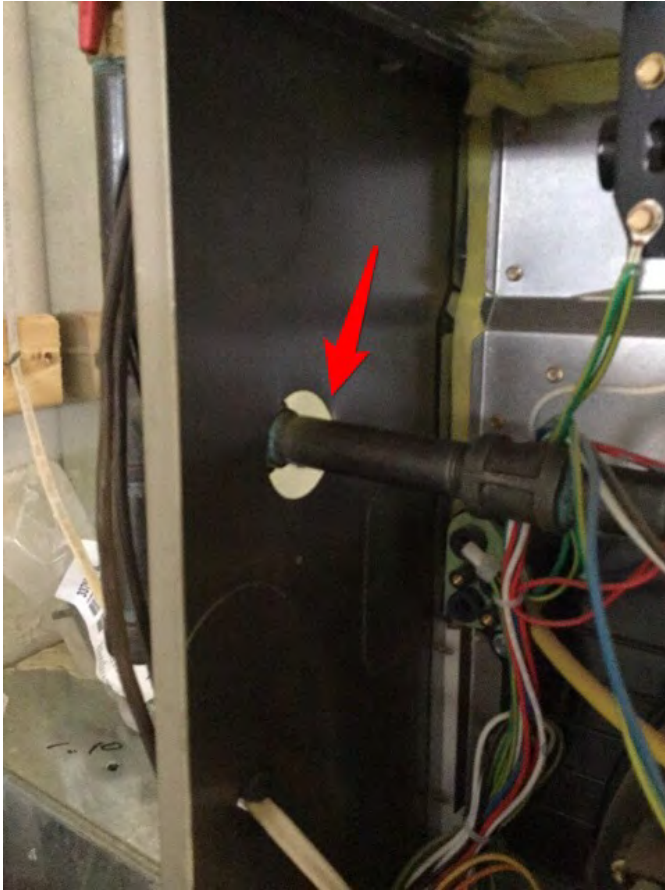
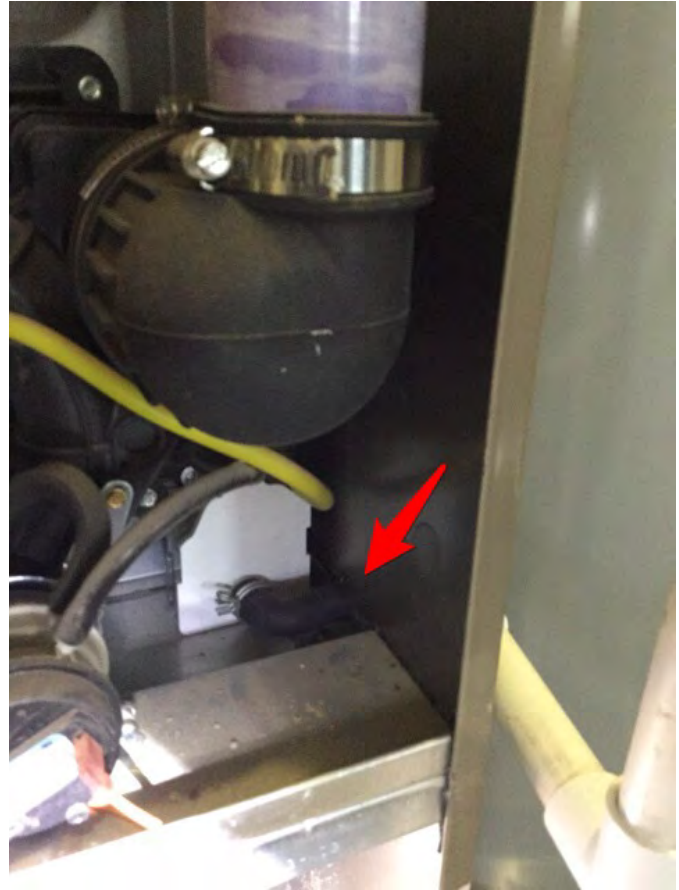
7: - Seals missing at opening thru furnace case for gas line and condensate drain line. This is a high efficiency furnace that relies on a sealed case to draw combustion air from outside rather than from furnace room. Missing seals will allow air to be drawn from room. Recommend installing seals at openings to properly seal furnace compartment.

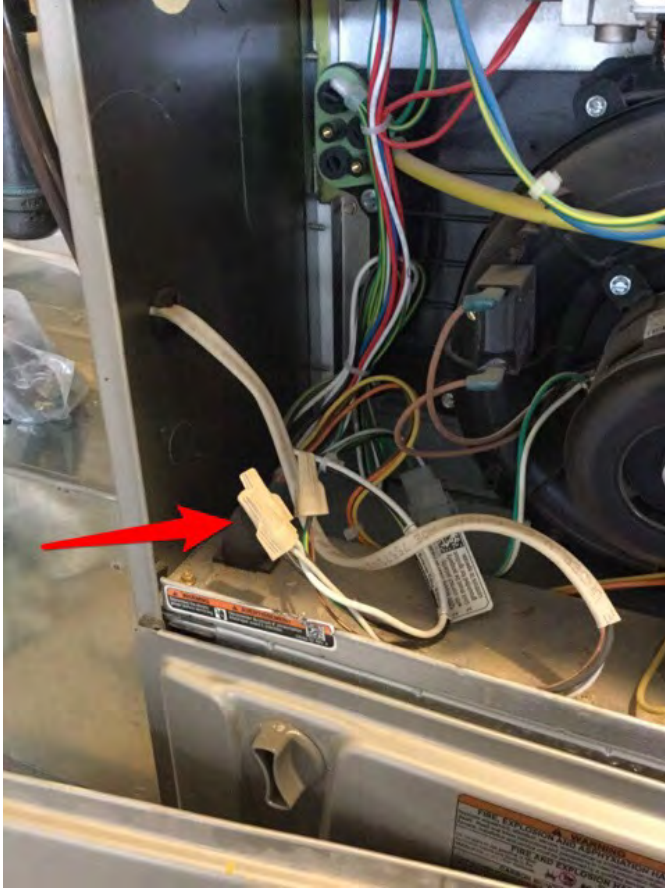
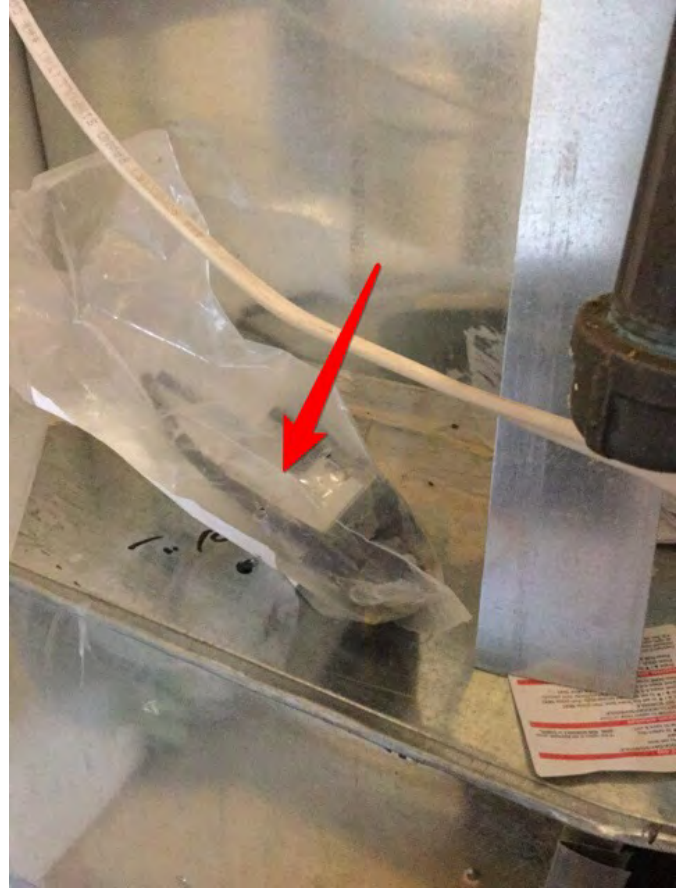
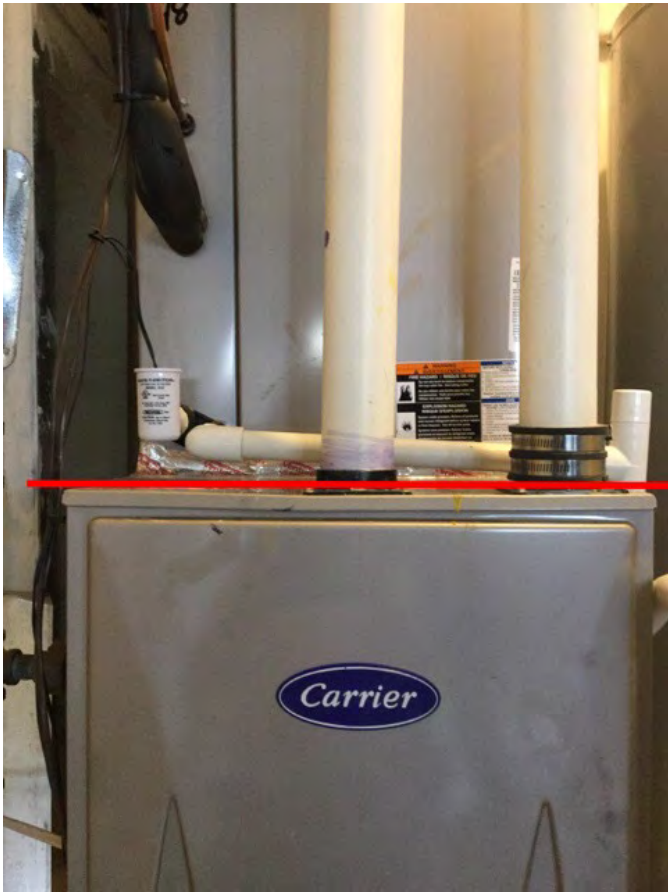
**8:** - Junction box supplied with unit not installed in furnace to protect 120 volt electric splices. Top of furnace case bent downward at middle, making installation of sealed cover difficult. Recommend review by a licensed heating contractor for proper installation, prior to close.

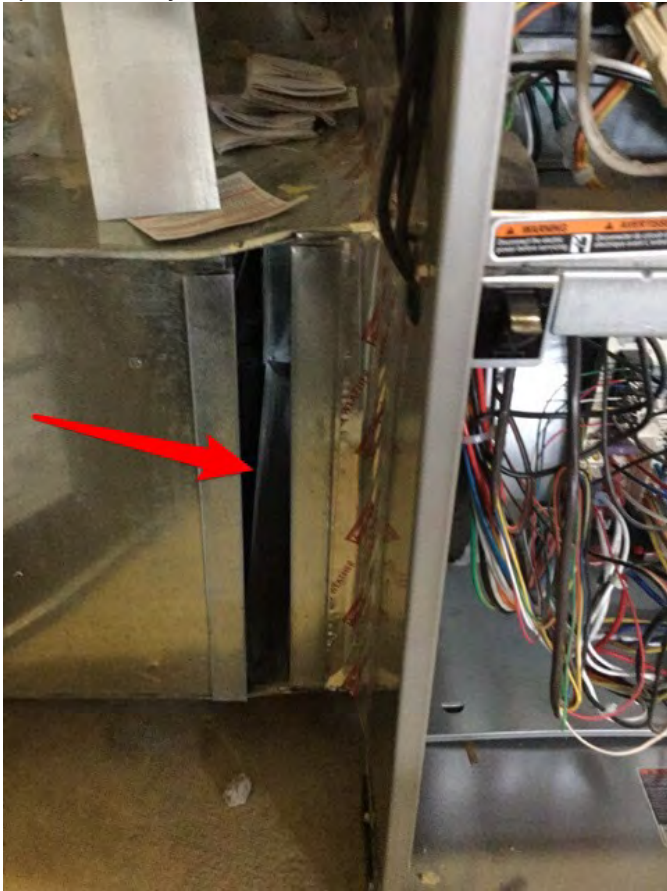
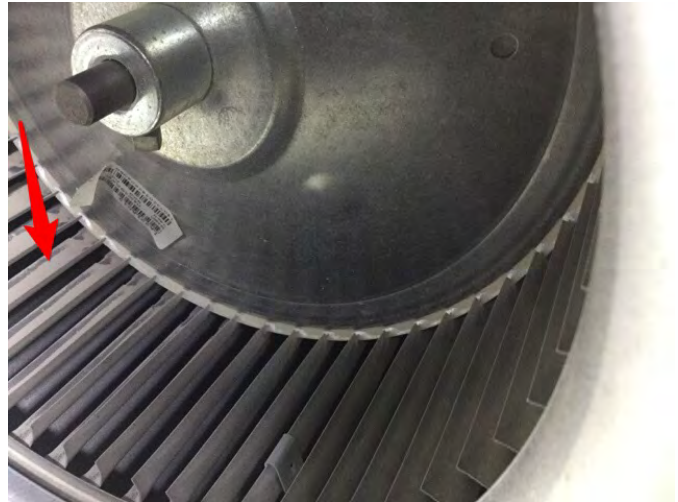
**9:** - No air filter installed in system. Blower dirty. Coil not visible, but also likely dirty. Air filters are necessary to prevent unfiltered air from dirtying system. Dirt on blowers and coils restricts the air flow thru the system. Proper air flow is necessary for comfort as well as energy efficiency and proper operation of system. Recommend installing proper filter and servicing/cleaning as needed by a licensed heating and air conditioning contractor prior to closing for proper operation of system.

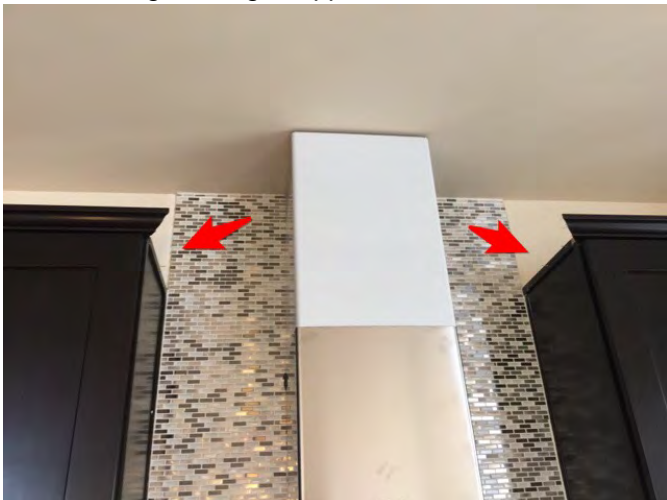
**10:** - Molding missing at upper cabinets at either side of exhaust vent. Recommend repairs/completing installation

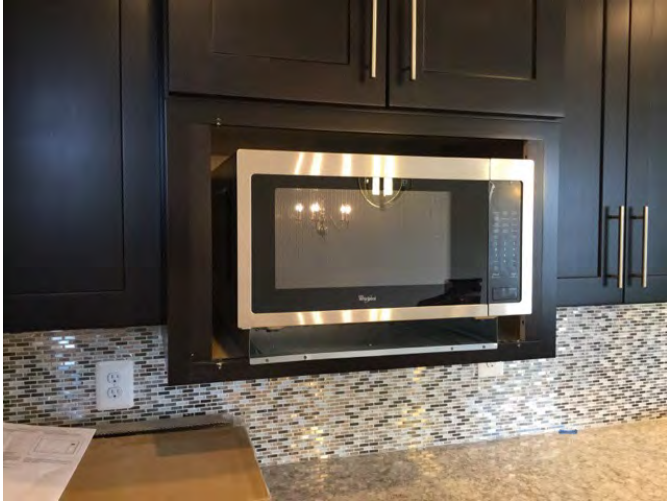
11: - Not connected. Installation incomplete

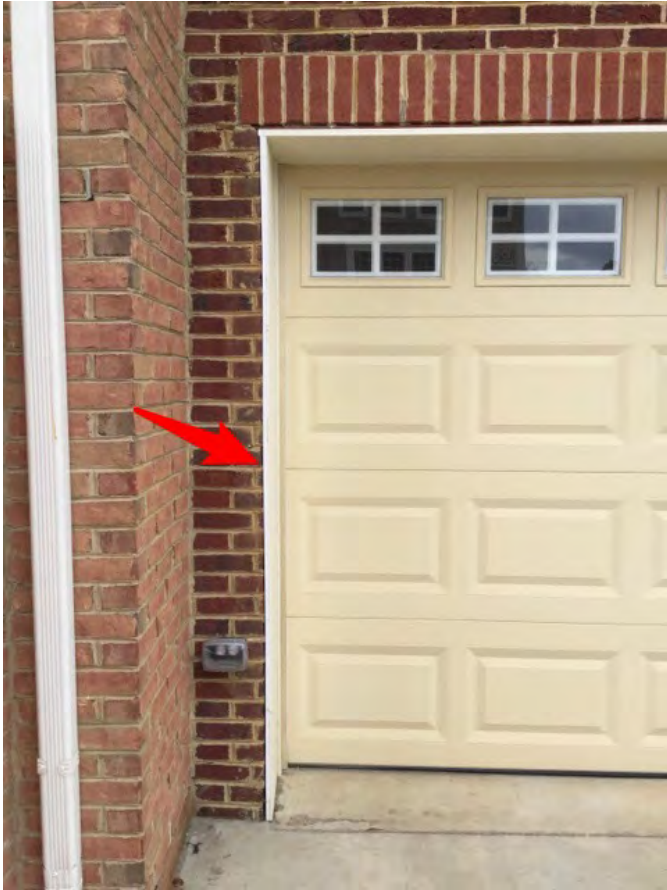
Missing trim at left side of garage door. Recommend installation

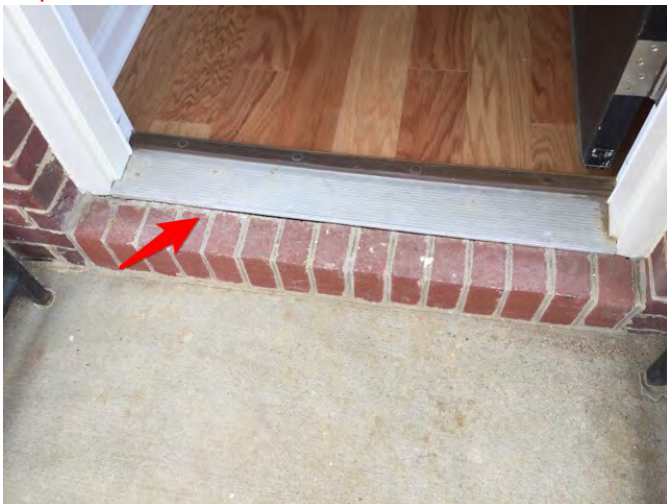
Gaps between brick and threshold at front door

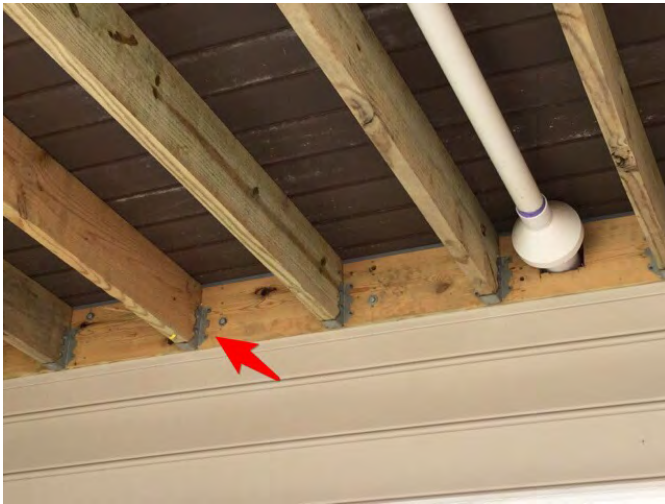
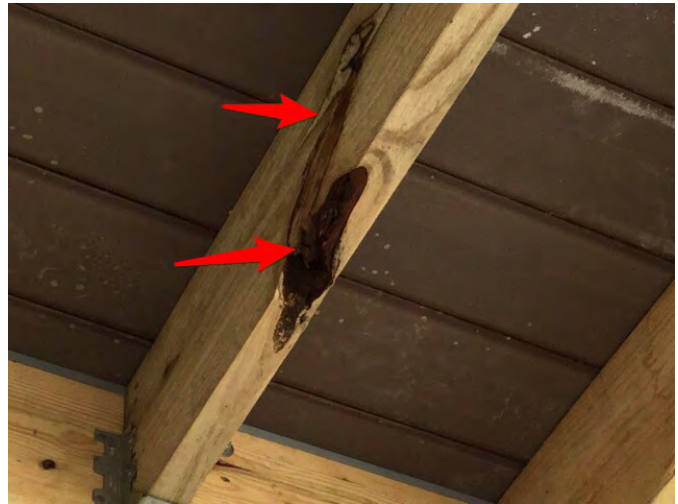
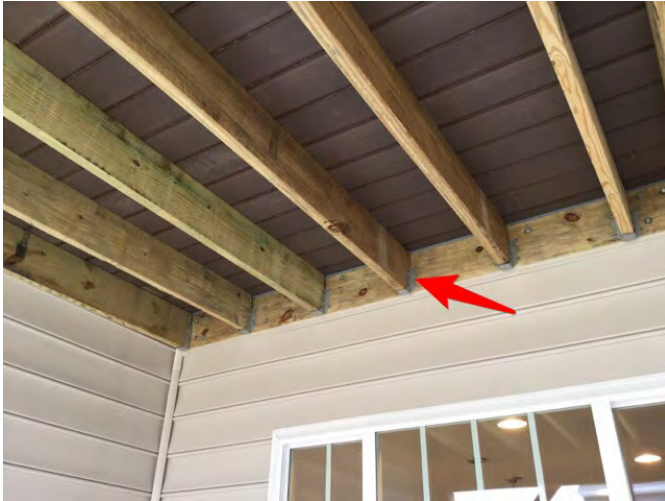
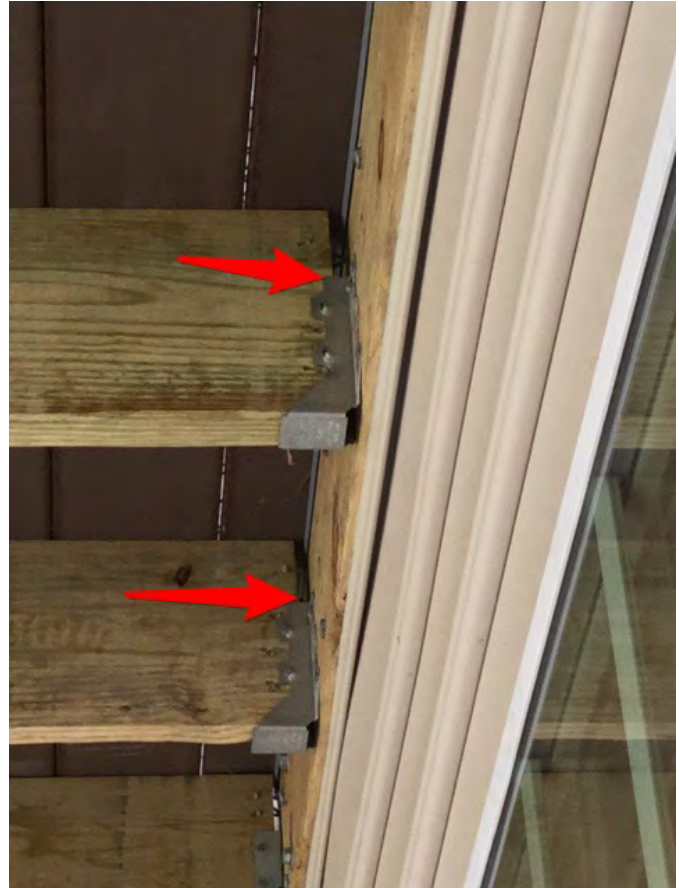
Joist hangers do not appear to be correct size for the joists at both levels. 2nd joist from this units exterior wall has significant knot that weakens board. Too much space between ledger board and joists at several joists. Recommend review by a qualified licensed contractor for repair/replacement as necessary for safety

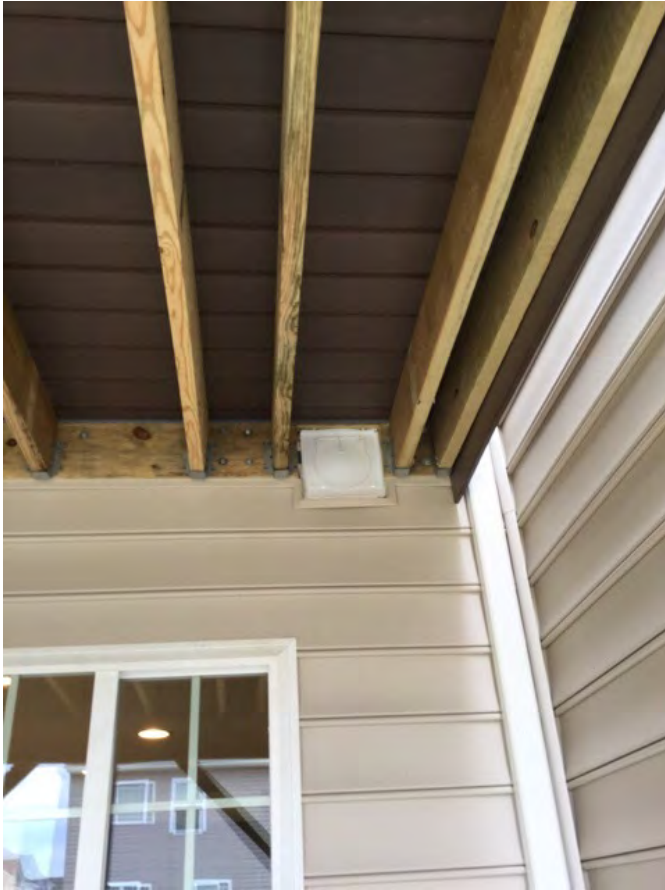
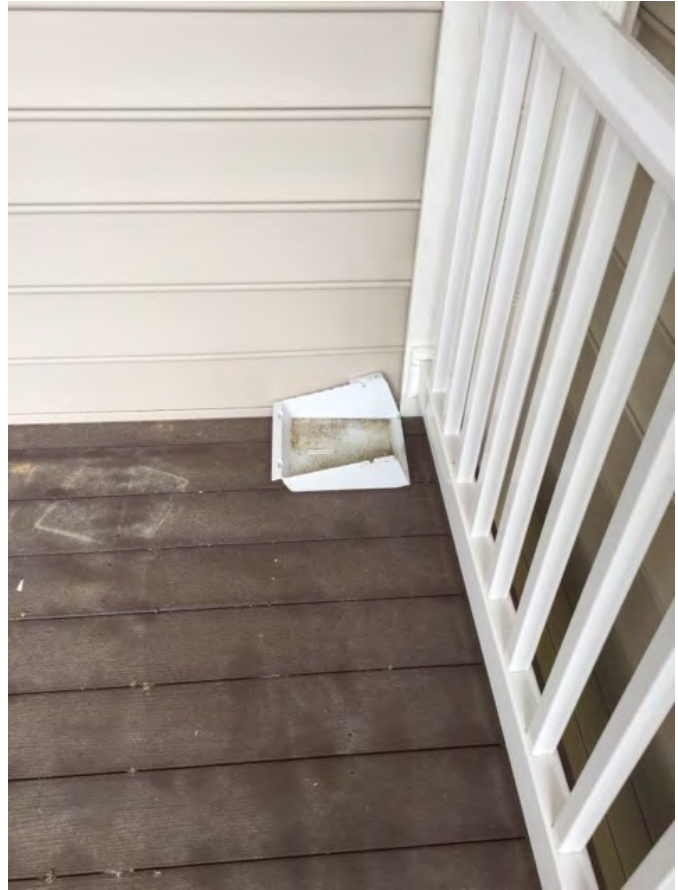
Exhaust vent cover is not installed. Repair needed

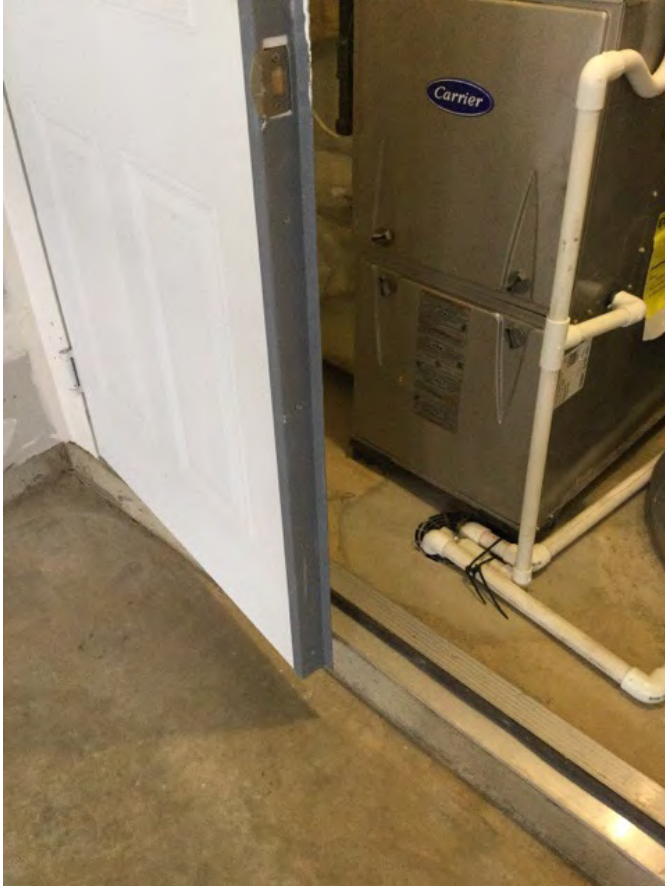
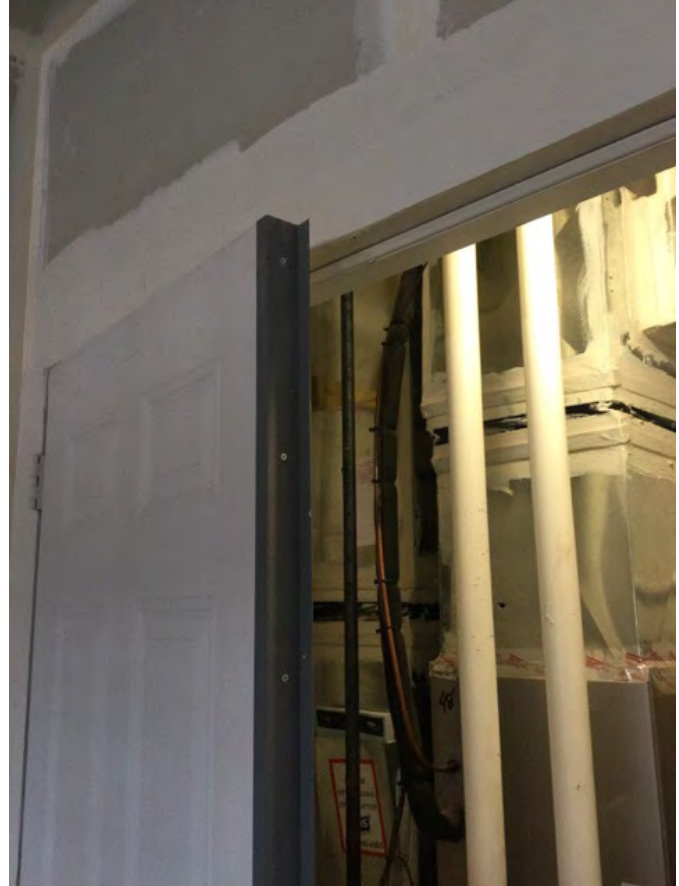
Fire door at furnace room does not have latches to secure at top and bottom of frame for striker plate side door. No seal at edge between doors. Air pressure would cause door to open during a fire, allowing fire into interior. Recommend repairs for door to latch and properly seal for fire safety

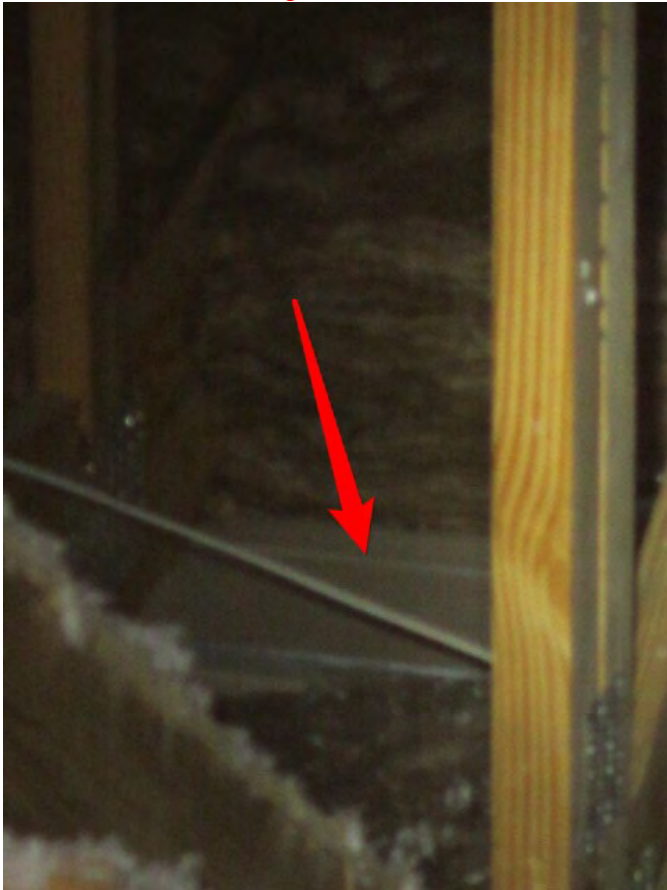
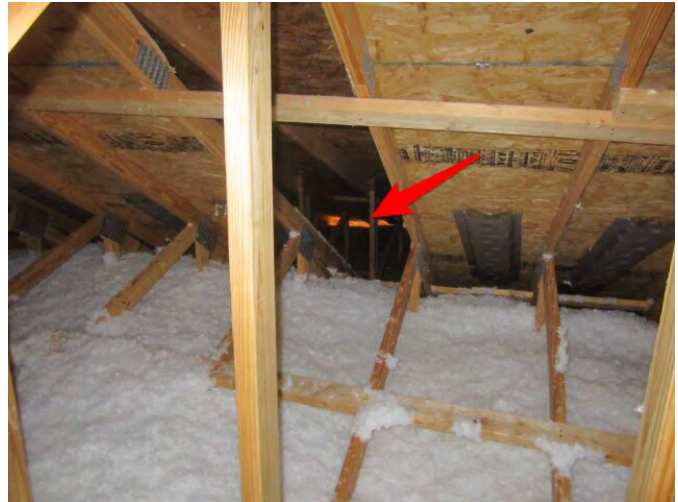
10-14" of insulation present except for missing piece/bare area above master bedroom. Recommend installing insulation where missing

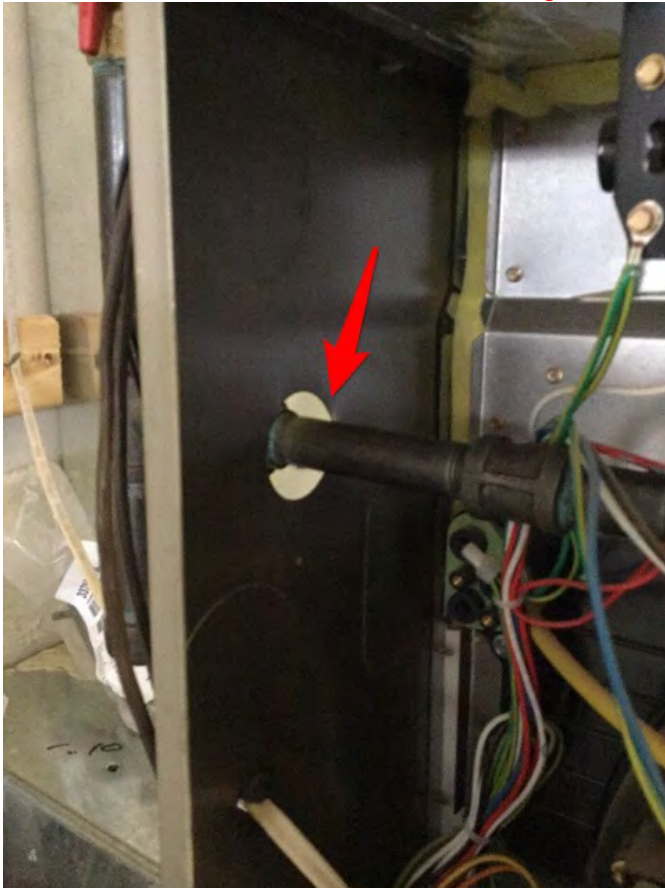
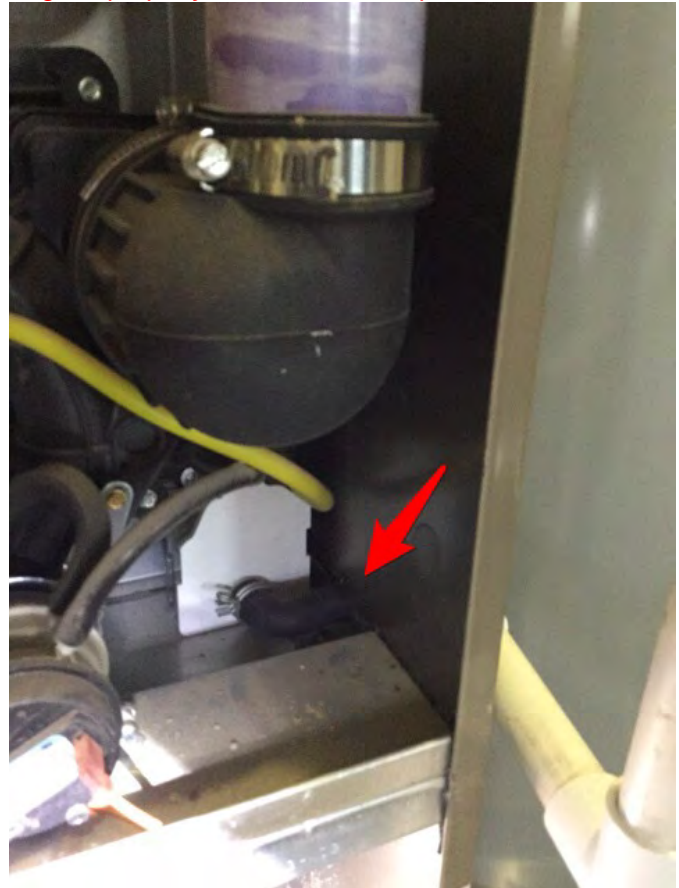
Seals missing at opening thru furnace case for gas line and condensate drain line. This is a high efficiency furnace that relies on a sealed case to draw combustion air from outside rather than from furnace room. Missing seals will allow air to be drawn from room. Recommend installing seals at openings to properly seal furnace compartment.

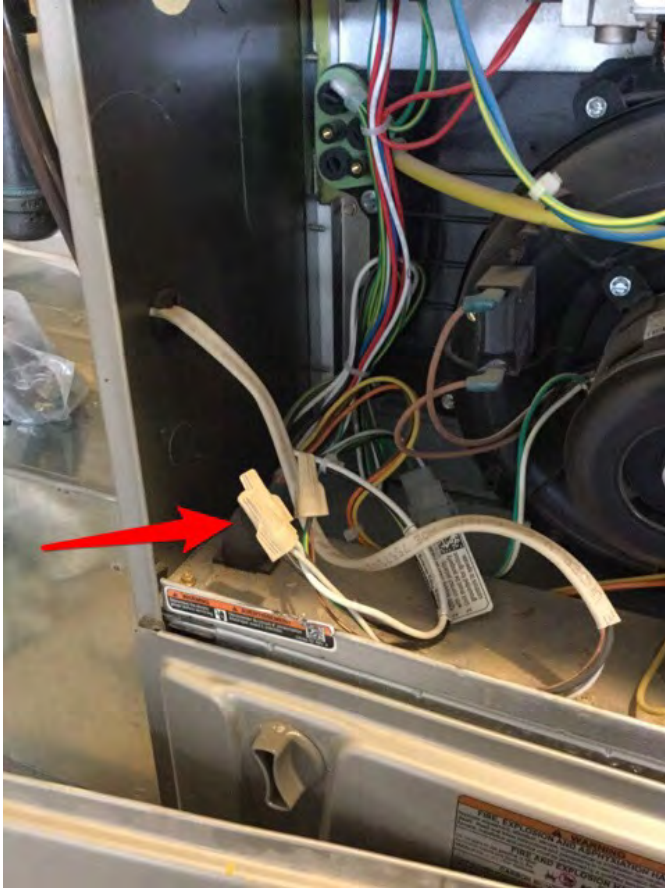
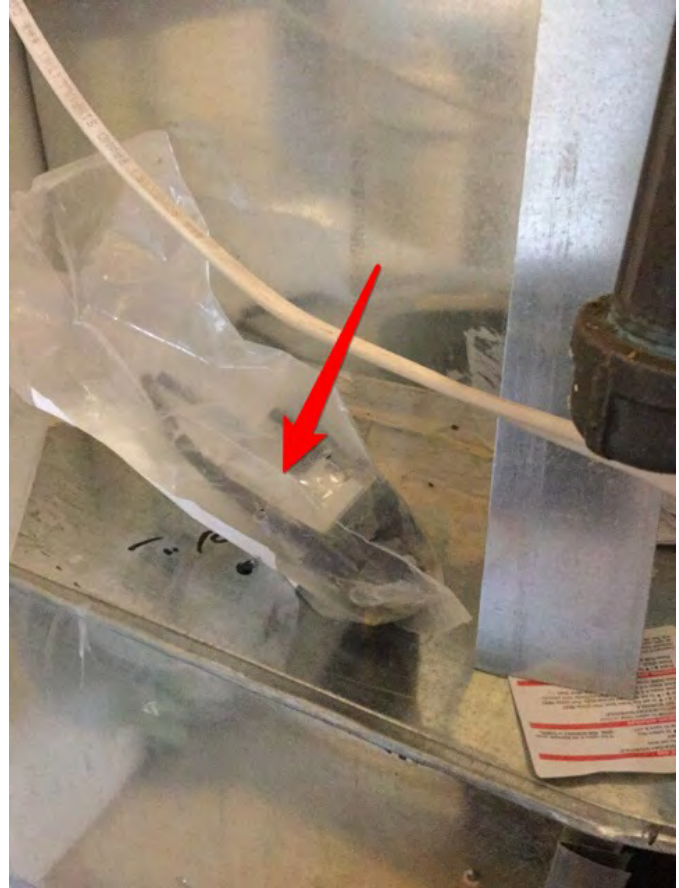
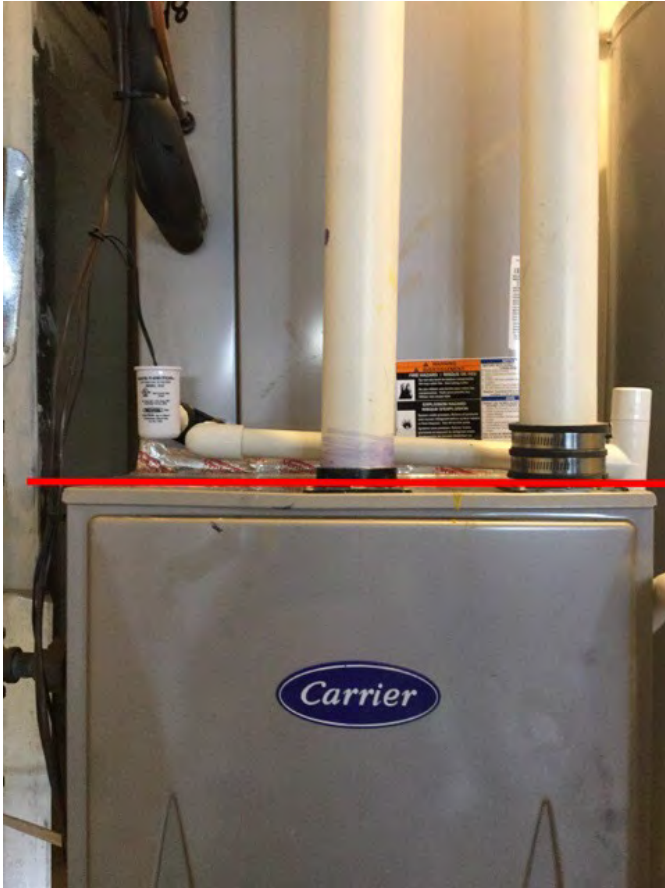
Junction box supplied with unit not installed in furnace to protect 120 volt electric splices. Top of furnace case bent downward at middle, making installation of sealed cover difficult. Recommend review by a licensed heating contractor for proper installation, prior to close.

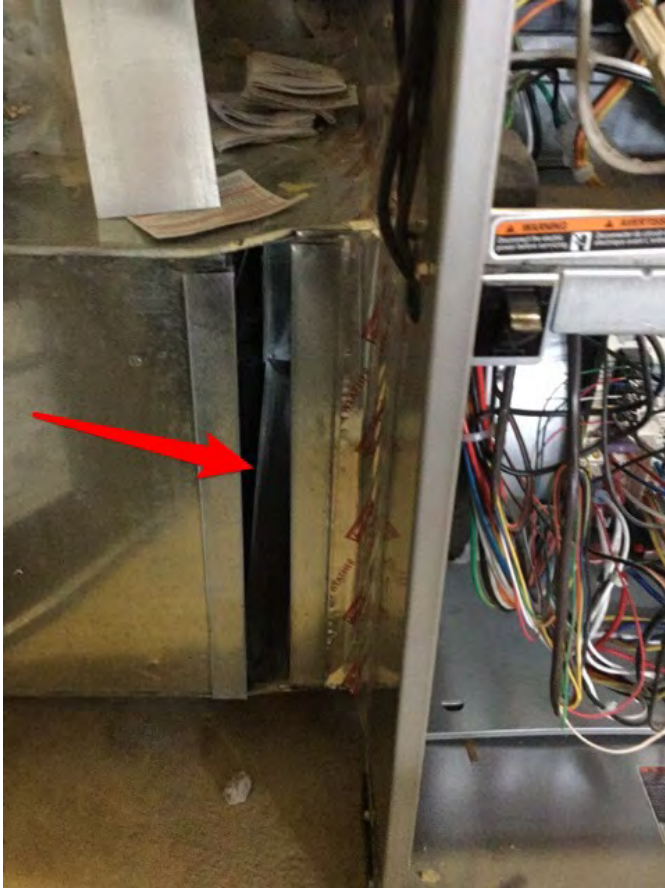
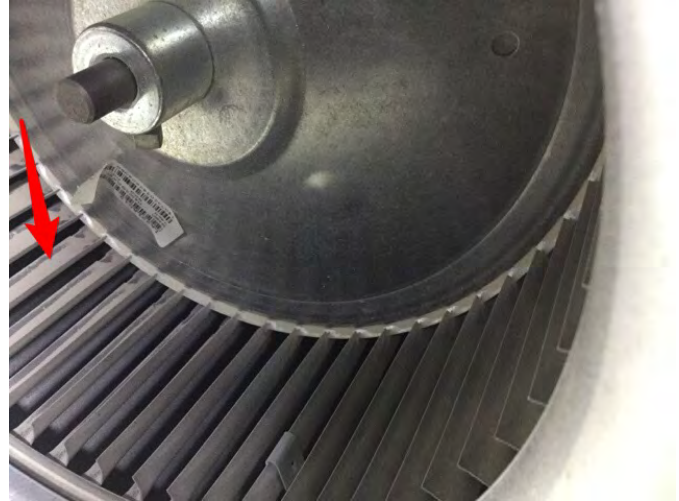
No air filter installed in system. Blower dirty. Coil not visible, but also likely dirty. Air filters are necessary to prevent unfiltered air from dirtying system. Dirt on blowers and coils restricts the air flow thru the system. Proper air flow is necessary for comfort as well as energy efficiency and proper operation of system. Recommend installing proper filter and servicing/cleaning as needed by a licensed heating and air conditioning contractor prior to closing for proper operation of system.

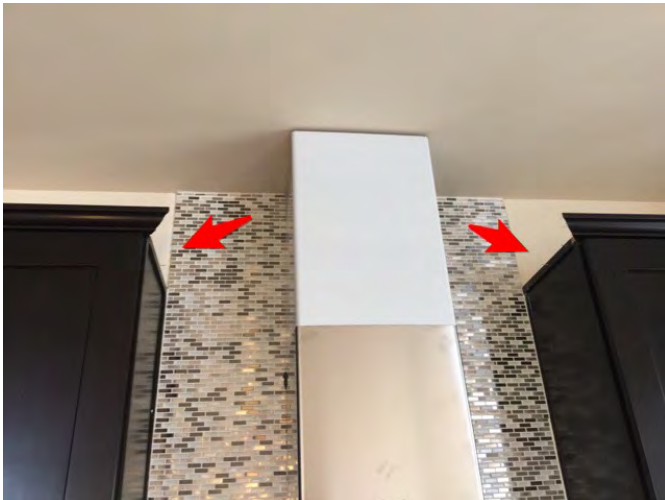
Molding missing at upper cabinets at either side of exhaust vent. Recommend repairs/completing installation

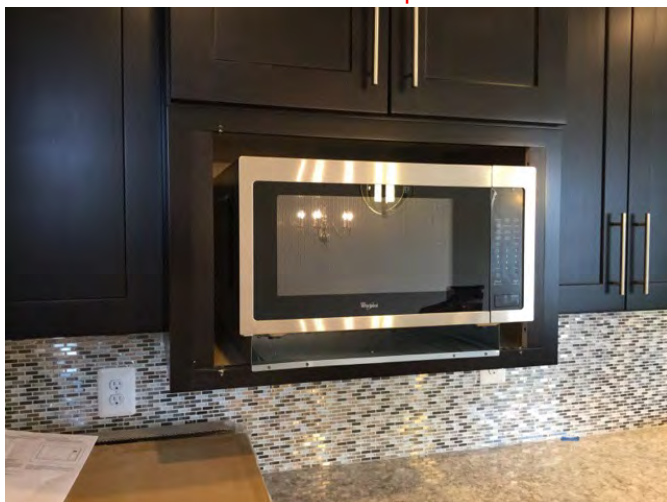
**Not connected. Installation incomplete**
